## 2.1.7 Field survey results

### 2.1.7.1 Field surveys

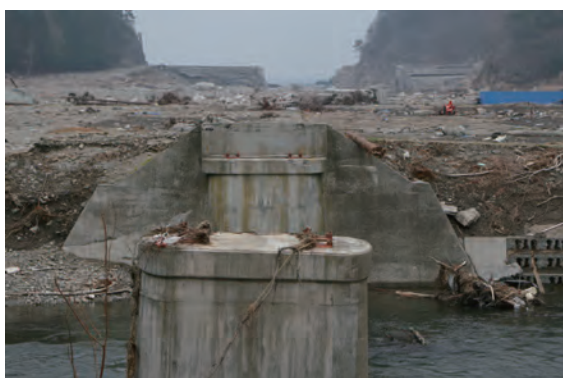
Figure 2.1-67 Settai district, Miyako City, Iwate  
The site of a village and a bridge claimed by the tsunami

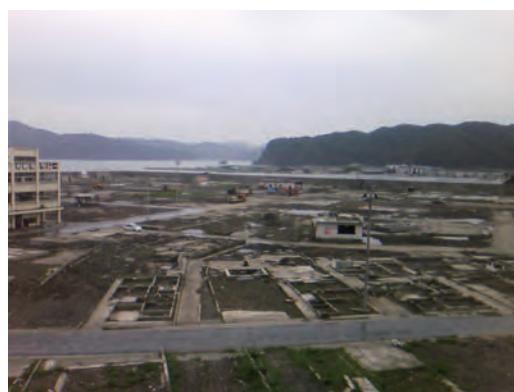
Figure 2.1-68 Taro district, Miyako City, Iwate  
Damage to an area with tsunami barriers

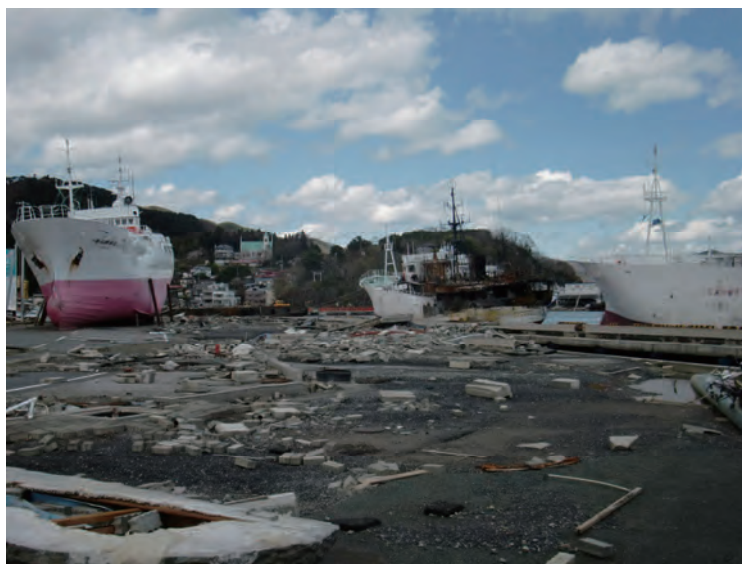
Figure 2.1-69 Harbor affected by subsidence in Kesennuma City, Miyagi

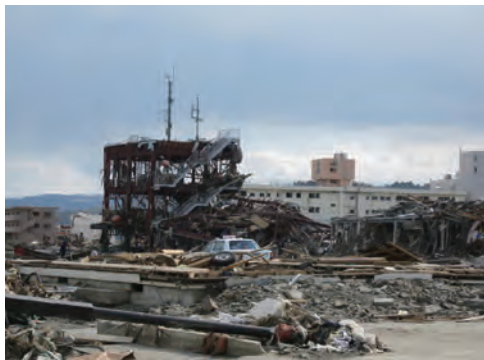
Figure 2.1-70 Minamisanriku Town, Miyagi  
 Damaged town hall  
 (Photo courtesy of Asia Air Survey Co., Ltd.)

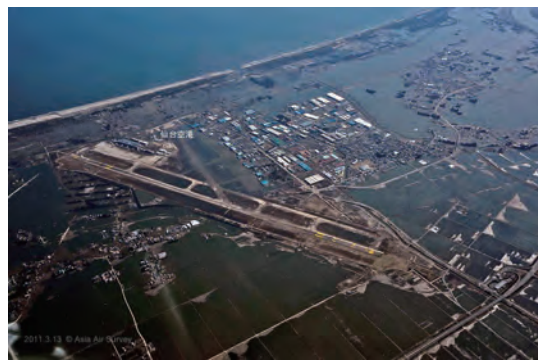
Figure 2.1-71 Natori City, Miyagi  
 Overview of flooding at Sendai Airport  
 (Photo courtesy of Asia Air Survey Co., Ltd.)
