2.1.3 Image analysis by JAXA

2.1.3.1 Overview of the damage

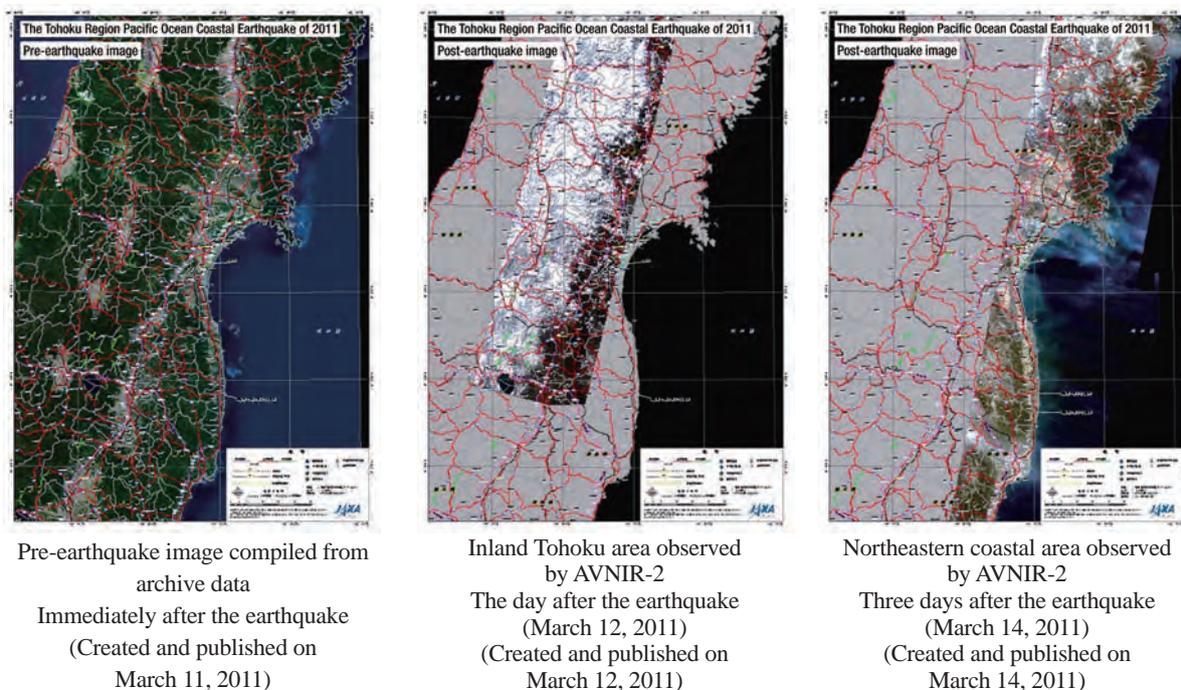
Figure 2.1-1 Pre- and post-disaster satellite topographical maps

JAXA created satellite topographical maps using the data acquired from its emergency observations and previously archived data by superimposing geographical data, and analyzed the disaster areas. The image on the left of Figure 2.1-1 shows a pre-earthquake satellite topographical map based on archived data, while those in the center and on the right show post-earthquake equivalents created by scattering mosaic patterns on AVNIR-2 images taken during emergency observations at around 10:25 JST on March 12 and 10:11 JST on March 14. Figure 2.1-2 shows a disaster area overview produced by AVNIR-2 on March 14.

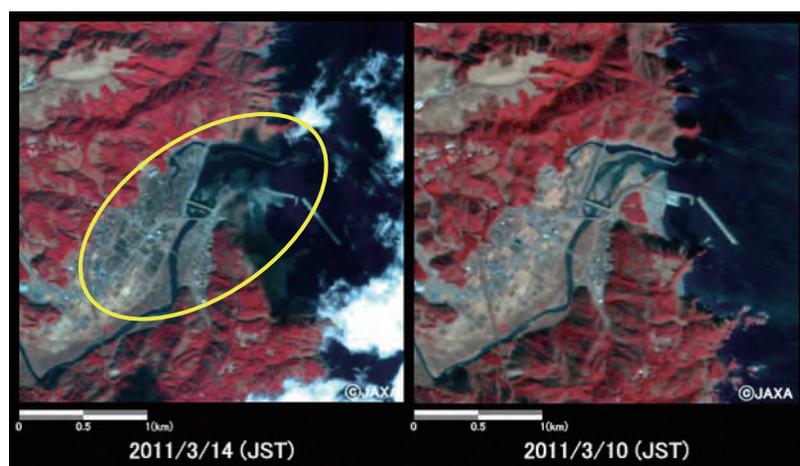
Figure 2.1-3 Flooding in the Omoto area of Iwaizumi Town in Iwate Prefecture (same 3×3 km area)
 Left: after the earthquake (March 14, 2011); right: before the earthquake (March 10, 2011)

AVNIR-2 acquired images with minimal cloud on March 14, three days after the disaster, thereby helping to clarify the extent of the damage in Iwate and Miyagi prefectures (the yellow-framed areas in Figure 2.1-2). For example, Figure 2.1-3 shows images of the Omoto area of Iwaizumi Town in Iwate Prefecture enlarged from false-color images produced from a composite of AVNIR-2 band 4, 3 and 2 images from March 14 (after the earthquake) and March 10 (before the earthquake). The clear contrast of areas of vegetation (shown in red) and cloud (white) help to clarify the conditions on the ground. Rice and crop fields are flooded (areas of dark blue after the disaster), and landslides can be seen at the mouth of the river.

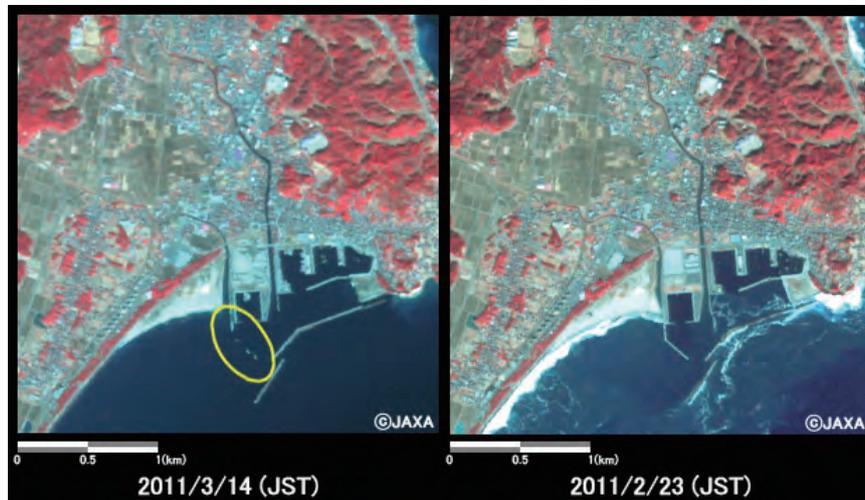
Figure 2.1-4 Kitaibaraki City, Ibaraki (same 3 × 3 km area)

Figure 2.1-4 shows enlarged pre- and post-disaster images of Kitaibaraki City in Ibaraki. Clear damage to the sea wall can be seen in the area enclosed in yellow.

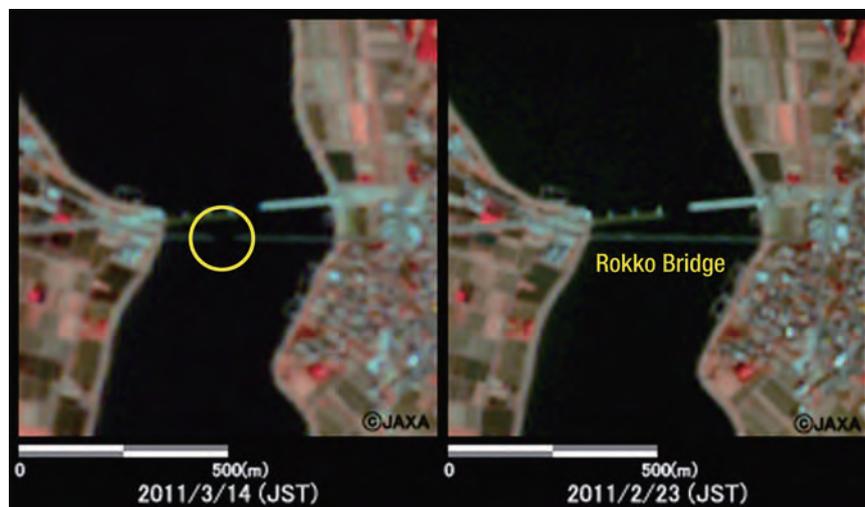
Figure 2.1-5 Area around Rokko Bridge in Ibaraki (same 1 × 1 km area)

Figure 2.1-5 shows enlarged images of Rokko Bridge in Ibaraki. It can be seen that the middle part of the bridge has collapsed. (Upper part: new bridge under construction)

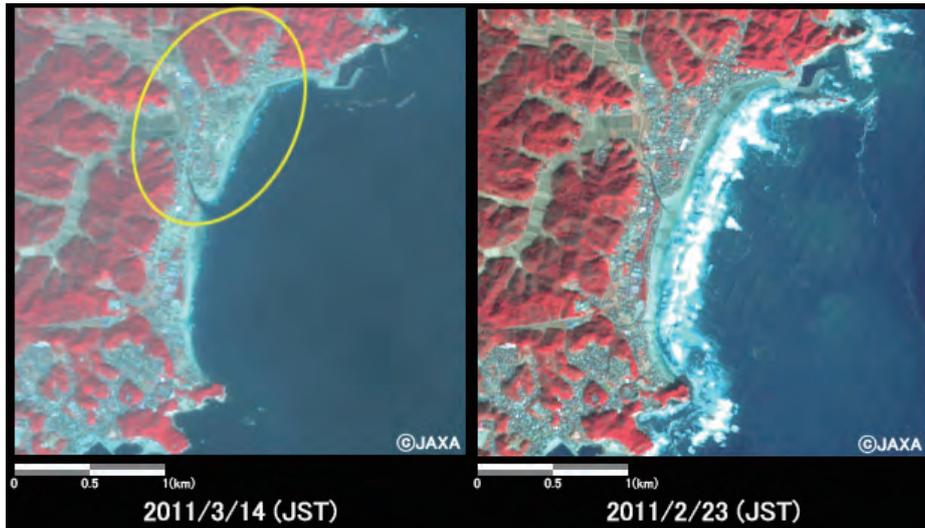
Figure 2.1-6 Yawata Town, Iwaki City, Fukushima (same 3 × 3 km area)

Figure 2.1-6 shows enlarged images of Yawata Town, Iwaki City, Fukushima. Collapsed buildings and other large-scale changes can be seen in the area enclosed in yellow.

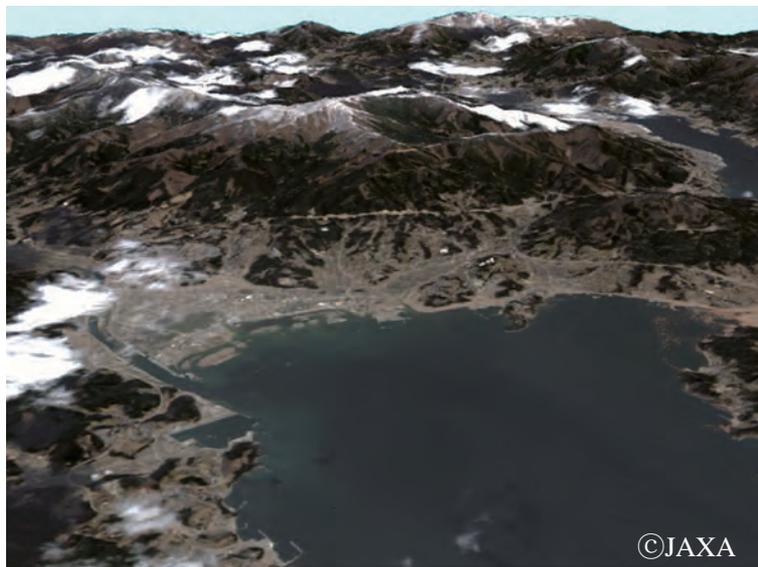
Figure 2.1-7 Post-quake bird's-eye view of the area around Rikuzentakata City, Iwate
(White areas: clouds and snow)

Figures 2.1-7 to 2.1-9 show pre- and post-earthquake bird's-eye views of Rikuzentakata City and Otsuchi Town in the Kamihei area of Iwate created by merging pan-sharpened images from AVNIR-2 and PRISM acquired on March 24, 2011, and November 6, 2010 with Digital Surface Model (DSM) images from PRISM. The images provide a three-dimensional view of the extensive destruction caused by the tsunami to bridges, embankments, urban areas and vegetation.

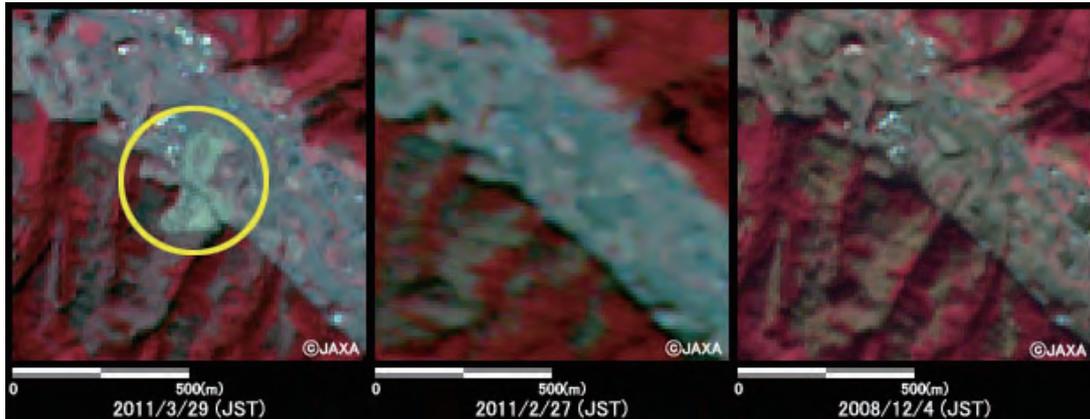
Figure 2.1-10 Oshino district of Nakagawa Town, Tochigi (same 1 × 1 km area)

Figure 2.1-10 shows enlarged images of the Oshino district of Nakagawa Town in Tochigi acquired from AVNIR-2 images observed after the earthquake on March 29, 2011 (left), before it on February 27, 2011 (center), and on December 4, 2008 (right). In the area enclosed in yellow, it can be seen that landslides destroyed areas of vegetation and approached buildings to the north.

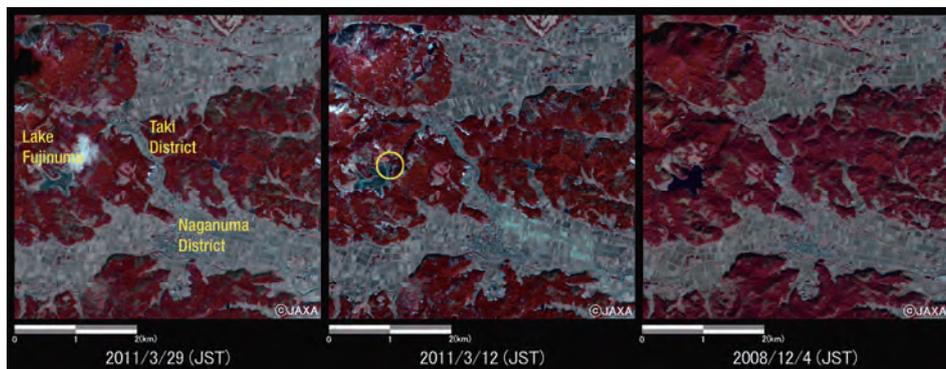
Figure 2.1-11 Area around Lake Fujinuma in Sukagawa City, Fukushima (same 5 × 5 km area)

Figure 2.1-11 shows enlarged images from AVNIR-2 of the area near Lake Fujinuma in Sukagawa City, Fukushima, after the earthquake on March 12 and 29, 2011, and before it on December 4, 2008. In the area enclosed in yellow, it can be seen that the lake burst, sending water into the Taki and Naganuma districts in the lower reaches of the river. It can also be seen that less water was remained in the lake.

Left: after the earthquake on March 29, 2011; center: after the earthquake on March 12, 2011; right: before the earthquake on December 4, 2008

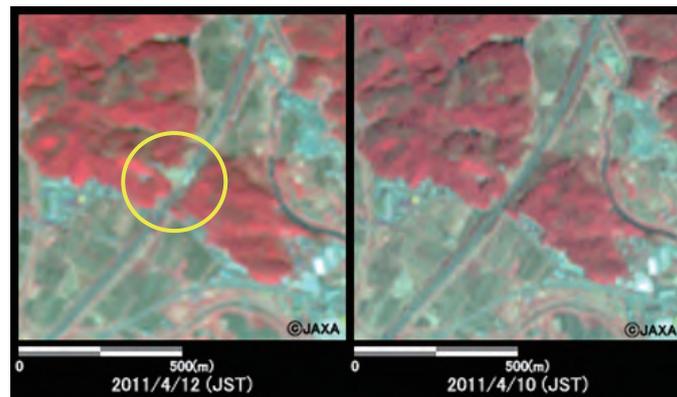
Figure 2.1-12 Joban Expressway in Iwaki City, Fukushima (same 1 × 1 km area)
Left: after the earthquake on April 12, 2011; right: before the earthquake on April 10, 2011

Magnitude 7.1 and 6.0 aftershocks occurred in Hamadori, Fukushima, at 17:17 on April 11, triggering landslides at various locations around Iwaki City. Figure 2.1-12 shows enlarged images of a landslide between Iwaki Nakoso IC and Iwaki Yumoto IC on the Joban Expressway taken after the aftershocks on April 12, 2011, and before the aftershocks on April 10, 2011. In the area enclosed in yellow, it can be seen that the landslide reached the expressway.

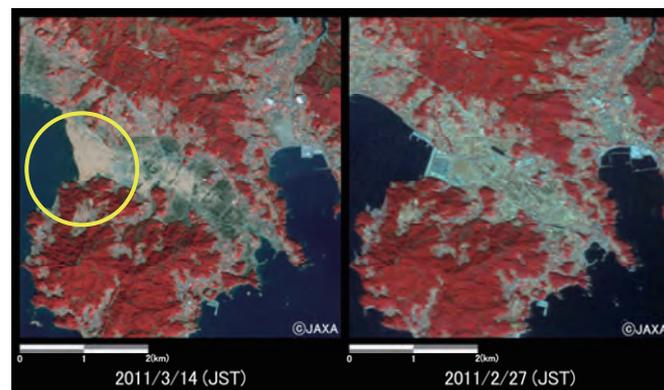
Figure 2.1-13 Aburasaki, Rikuzentakata City, Iwate (same 5 × 5 km area)
Left: after the earthquake on March 14, 2011; right: before the earthquake on February 27, 2011

Figure 2.1-13 shows enlarged images from AVNIR-2 taken after the earthquake on March 14, 2011 and before it on February 27, 2011, around Aburasaki, Rikuzentakata City, Iwate. It can be seen that a large amount of marine debris washed into the bay and that plains were flooded.

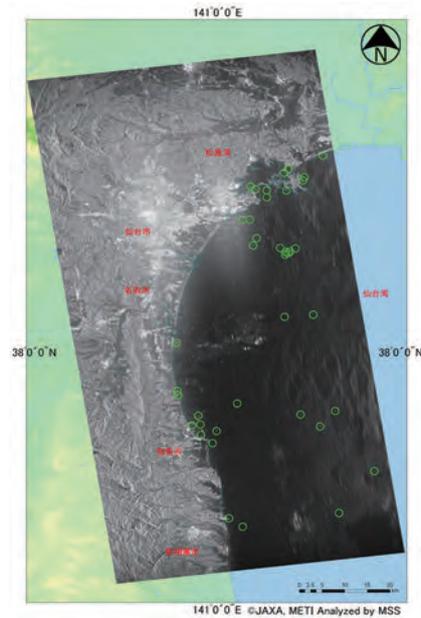
Figure 2.1-14 Marine debris observed by PALSAR (near Sendai Bay)
(around 22:11 on March 13, 2011)

Figure 2.1-14 shows an image from PALSAR observed around Sendai Bay on March 13. The green circles show debris; roughly 30 objects can be seen. The many white lines extending from north to south are caused by a phenomenon called ambiguity, in which bright land reflects on the dark surface of the sea.

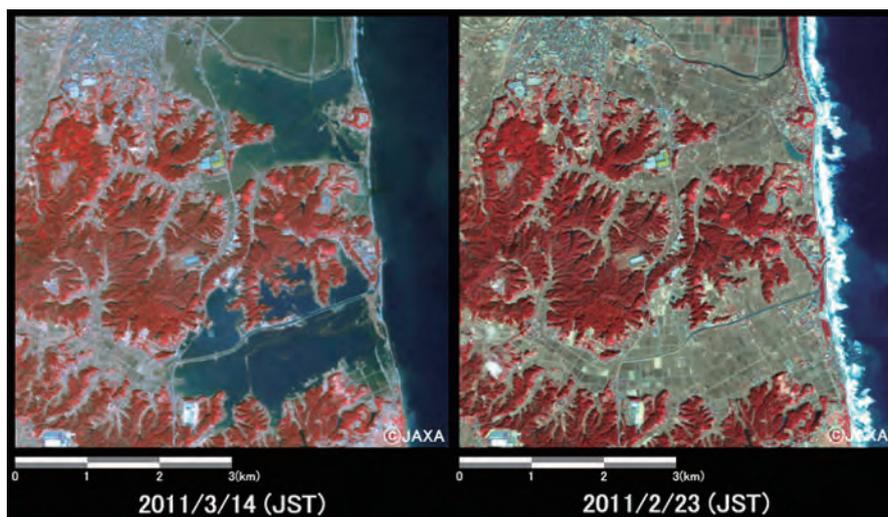
Figure 2.1-15 Flooding around Odaka, Minamisoma City, Fukushima (same 6 × 6 km area)

Satellite observations are effective in determining the extent of tsunami-related flooding. Figure 2.1-15 shows enlarged pre- and post-earthquake images of the area around the Odaka district of Soma City in Fukushima taken by AVNIR-2 on March 14 and February 23. Areas of vegetation (shown in red) are still present, but extensive flooding is seen in rice fields and other areas of arable fields (shown in dark blue).

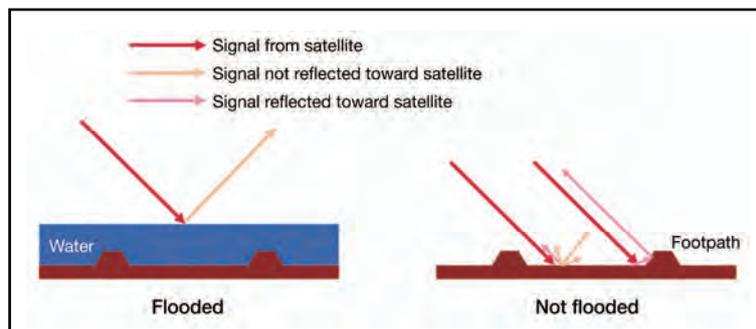
Figure 2.1-16 Difference in signal reflection with and without floodwater

Observations using PALSAR also help to identify areas of flooding based on the properties of reflection. As shown in Figure 2.1-16, most signals transmitted from the satellite bounce off water when flooding is present, which results in less reflection back toward the satellite and makes terrain appear darker (left). After the floodwater dissipates, signal reflection back to the satellite is increased, making terrain appear lighter (right).

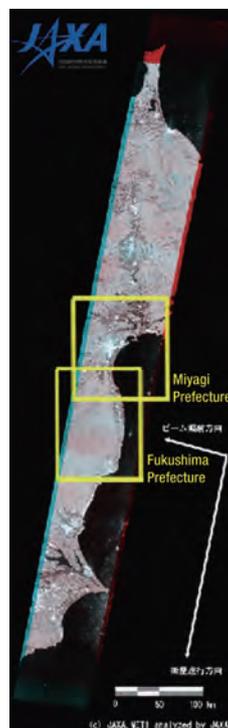
Figure 2.1-17 Pseudo-color PALSAR image

Based on this characteristic, Figure 2.1-7 shows a pseudo-color image from PALSAR consisting of images observed on April 2 (red, incidence angle: 41.4°) and March 16, 2011 (green and blue, incidence angle: 43.4°). The images are merged to highlight changes along the Pacific coast from the Shimokita Peninsula to Chiba.

(R: observation on April 2 (incidence angle: 41.4°); G, B: observation on March 16 (incidence angle: 43.4°))

The geographical features of the two pseudo-color images were adjusted to compensate for their different incidence angles. The coastal areas of Miyagi and Fukushima shown in Figure 2.1-17 are enlarged in Figure 2.1-18.

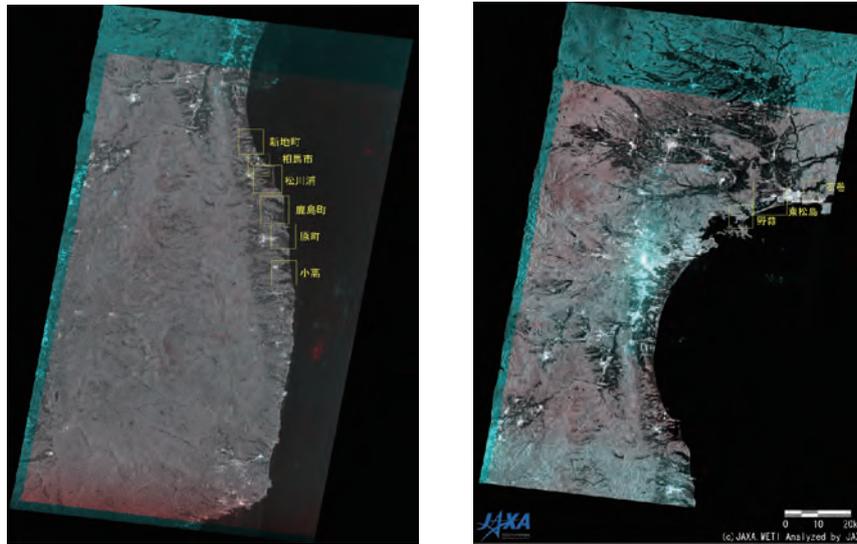
Figure 2.1-18 Enlarged images of coastal areas in Fukushima and Miyagi

Left: coastal area of Fukushima; right: coastal area of Miyagi

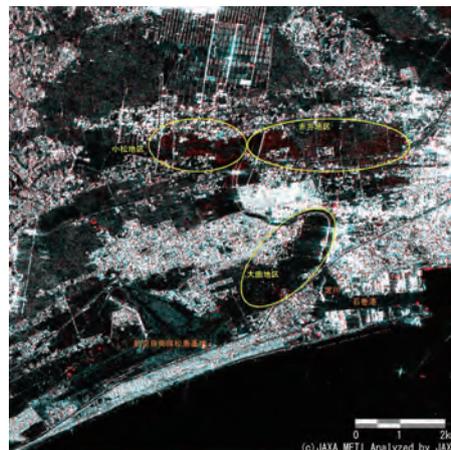
Figure 2.1-19 Enlarged image of the area around Ishinomaki

Figure 2.1-19 shows an enlarged image of the Ishinomaki area from Figure 2.1-18, which is a part of areas where changes can be seen between the two pseudo-color images shown in Figure 2.1-18 for March 16 and April 2. Areas that are lighter in the former (i.e., those with higher levels of reflection) than in the latter are indicated in blue, while those that are lighter in the latter are shown in red.

The rice fields along the Mano River (including those in the districts of Ouri, Negishi and Takaki) look dark due to floodwater, but are all lighter in the April image. This is because the ground surface was exposed as the floodwater dissipated, resulting in increased signal reflection.

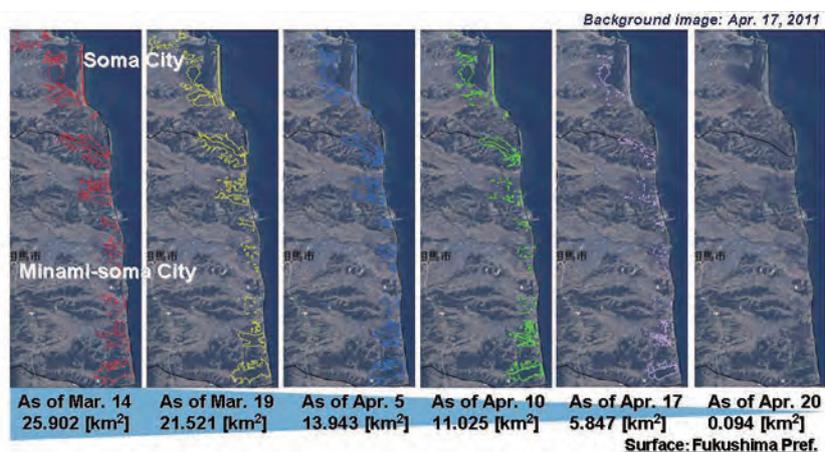
Figure 2.1-20 Results of observation by AVNIR-2 to determine total areas of flooding in the Fukushima cities of Soma and Minamisoma

The total area of flooding in each prefecture was determined using pre- and post-earthquake images from AVNIR-2, and the results are shown in Table 2.1-4. Zero is shown for areas where observation was not possible due to clouds and for those where no flooding occurred. The results, classified into municipal government areas, were provided to central government ministries and agencies. By way of example, Figure 2.1-20 shows the results for the cities of Soma and Minamisoma. It can be seen that coastal areas were extensively flooded just after the disaster on March 14, and that the floodwater dissipated over time. Similar analysis was also conducted with images from PALSAR (see Section 2.1.7.2 for the analysis results).

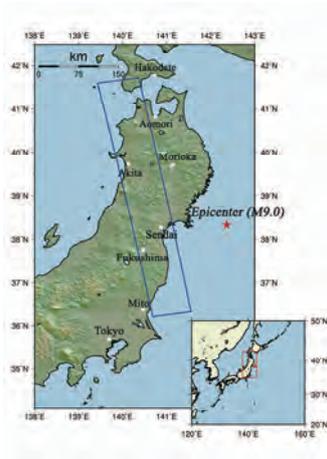
Figure 2.1-21 Range of PALSAR observation to detect crustal movement

Differential interferometric synthetic aperture radar (DInSAR) analysis was performed to detect crustal movement in relation to the Great East Japan Earthquake by comparing pre- and post-earthquake images acquired from the same orbit on April 18 and March 3, 2011.

SRTM3 data were used to provide digital elevation models. The red star shows the epicenter of the Great East Japan Earthquake.

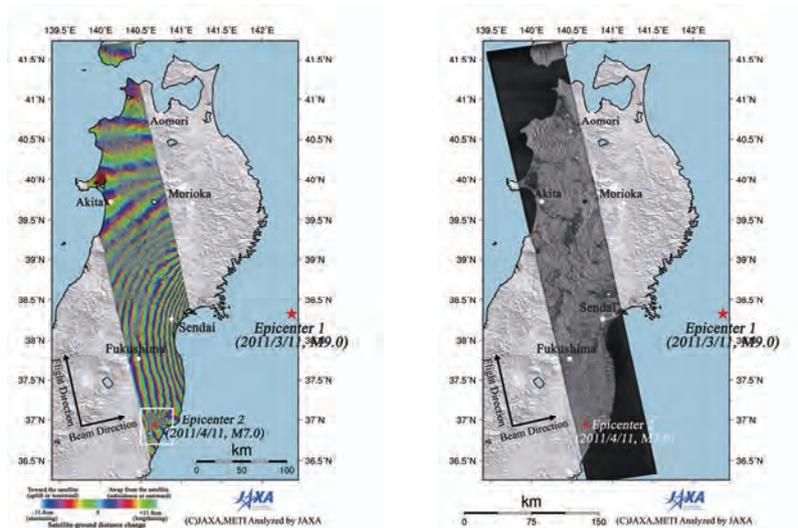
Figure 2.1-22 DInSAR images from PALSAR showing crustal deformation

The image on the left of Figure 2.1-22 was generated from PALSAR data acquired before the disaster (on March 3) and after it (on April 18) using differential interferometric SAR (DInSAR), and the image on the right is from PALSAR observation after the earthquake. Interference fringes (rainbow-color stripes) are seen in most parts of the left DInSAR image, indicating extensive crustal deformation typical of a massive earthquake. Diastrophism resulting in movement of around 2.6 m away from the satellite (including the gaps toward the east) is also seen in coastal areas of Sendai City in the vicinity of the epicenter.

Left: DInSAR image from PALSAR (crustal deformation). The section in the white frame is enlarged in Figure 2.1-23.

Right: PALSAR image taken after the earthquake. The Epicenter 1 star shows the focal point of the Great East Japan Earthquake (M 9.0), and the Epicenter 2 star shows that of the earthquake centered on Hamadori in Fukushima on April 11, 2011 (M 7.0). (Epicenter 2 data courtesy of the Japan Meteorological Agency)

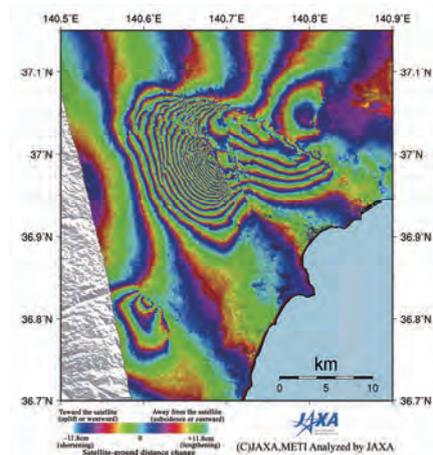
Figure 2.1-23 Enlarged DInSAR image from PALSAR (crustal movement)
(area shown in the white frame in Figure 2.1-22)

In Figure 2.1-23, regional interference fringes that differ significantly from those around them can be seen. This is considered to stem from crustal deformation associated with the April 11 2011 Fukushima Hamadori earthquake (M 7.0), which is thought to have caused crustal movement of 2 m or more around the epicenter.

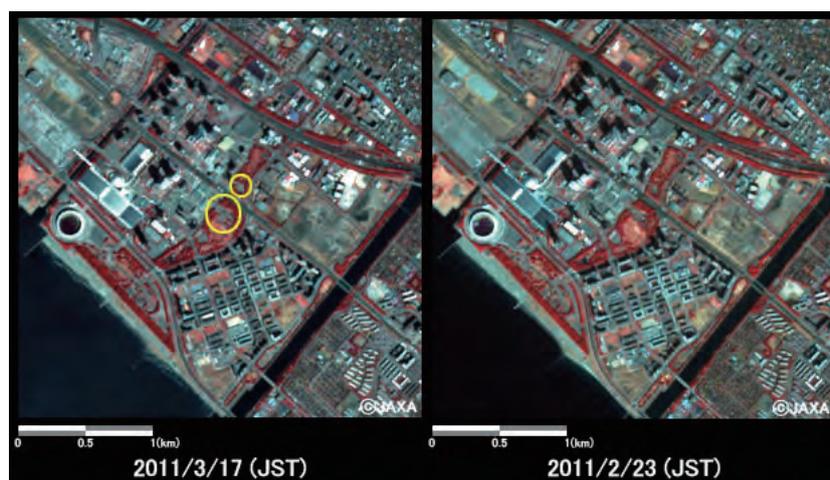
Figure 2.1-24 Kaihin-Makuhari Station in Chiba (same 3 × 3 km area)

Figure 2.1-24 shows enlarged images of the area around Kaihin-Makuhari Station on the Keiyo Line in Chiba based on AVNIR-2 data acquired after the earthquake on March 17, 2011 (left) and before the earthquake on February 23, 2011 (right). The areas circled in yellow show a lighter shade of gray after the earthquake due to liquefaction, which brought moist sand up to the ground surface. An example of this phenomenon is shown in the photo in Figure 2.1-25, taken on March 18, 2011.

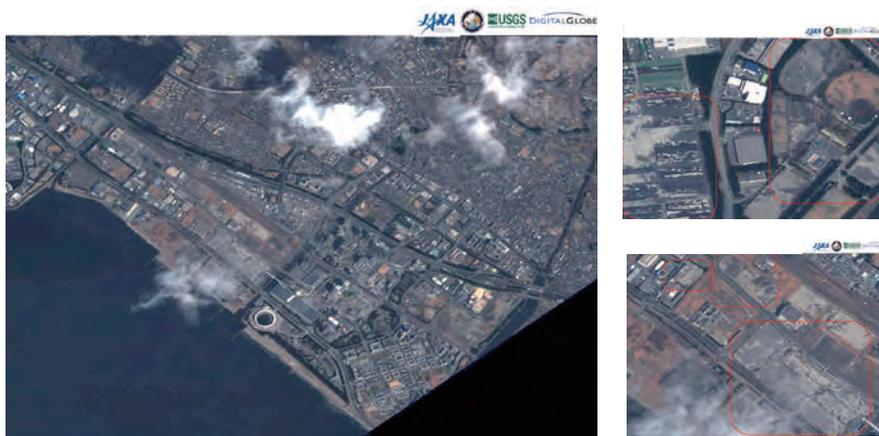
Figure 2.1-26 Areas of liquefaction between Makuhari Hongo and Makuhari stations

Figure 2.1-26 shows the results of liquefaction detection in a high-resolution image of the coastal area between Makuhari Hongo and Makuhari stations taken at 10:57 JST on March 17 2011 by the United States' WorldView-2 satellite, whose data is provided through Disaster Charter.

Left: overview; right: enlargement

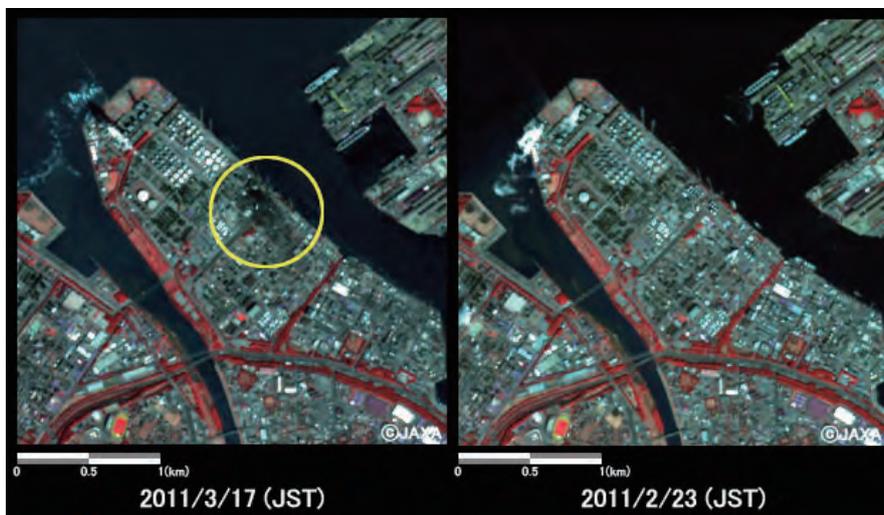
Figure 2.1-27 Oil refinery in Ichihara City, Chiba (same 3 × 3 km area)

Figure 2.1-27 shows enlarged pre- and post-earthquake images of the area around an oil refinery in Ichihara City, Chiba, observed by AVNIR-2 on March 17, 2011 (left) and on February 23, 2011 (right).

The black area circled in yellow is the site of a fire caused by the Earthquake.

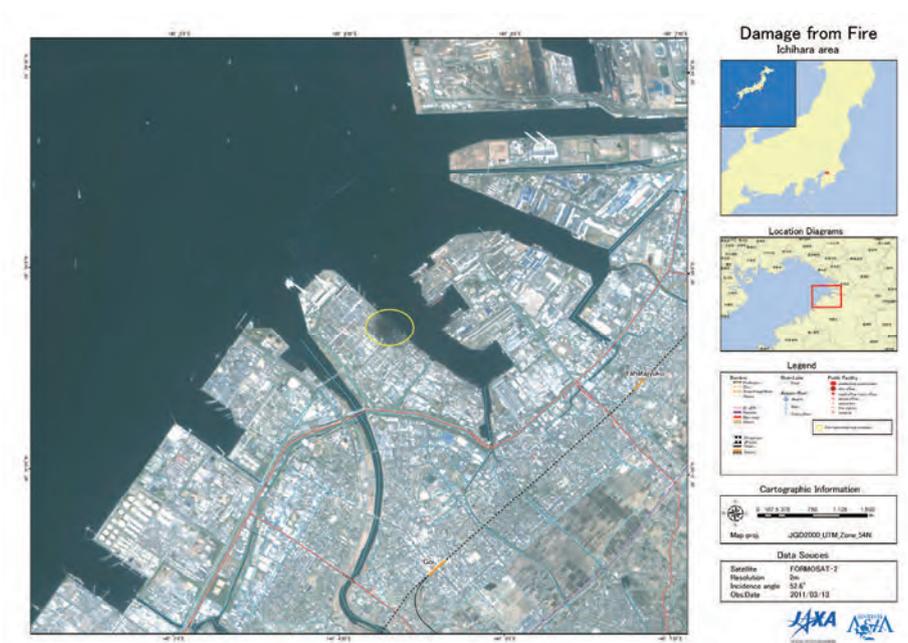
Figure 2.1-28 Satellite topographical image showing the area of the oil refinery fire in Ichihara City, Chiba

Figure 2.1-28 shows a satellite topographical image in which the area of the fire at the oil refinery can be seen. This is based on an image observed by FORMOSAT-2 on March 13 2011 through Sentinel Asia.
